# **Navajo Abandoned Uranium Mine**

## **Site Screen Report**

**Mine Name: Copper Point**  
**Mine ID: 389**

**April 2012**

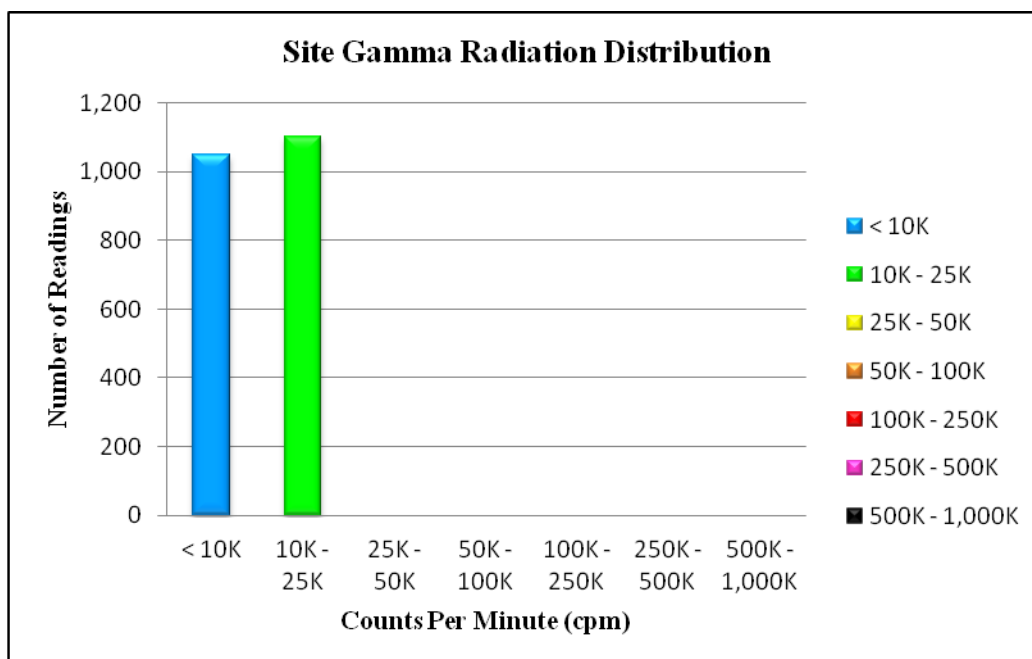
### Distribution Chart and Statistics:

Site Gamma Radiation Statistics	
Number of Readings	2,150
Minimum (cpm)	5,118
Maximum (cpm)	15,873
Mean (cpm)	9,884
Median (cpm)	10,038
Standard Deviation	1,820

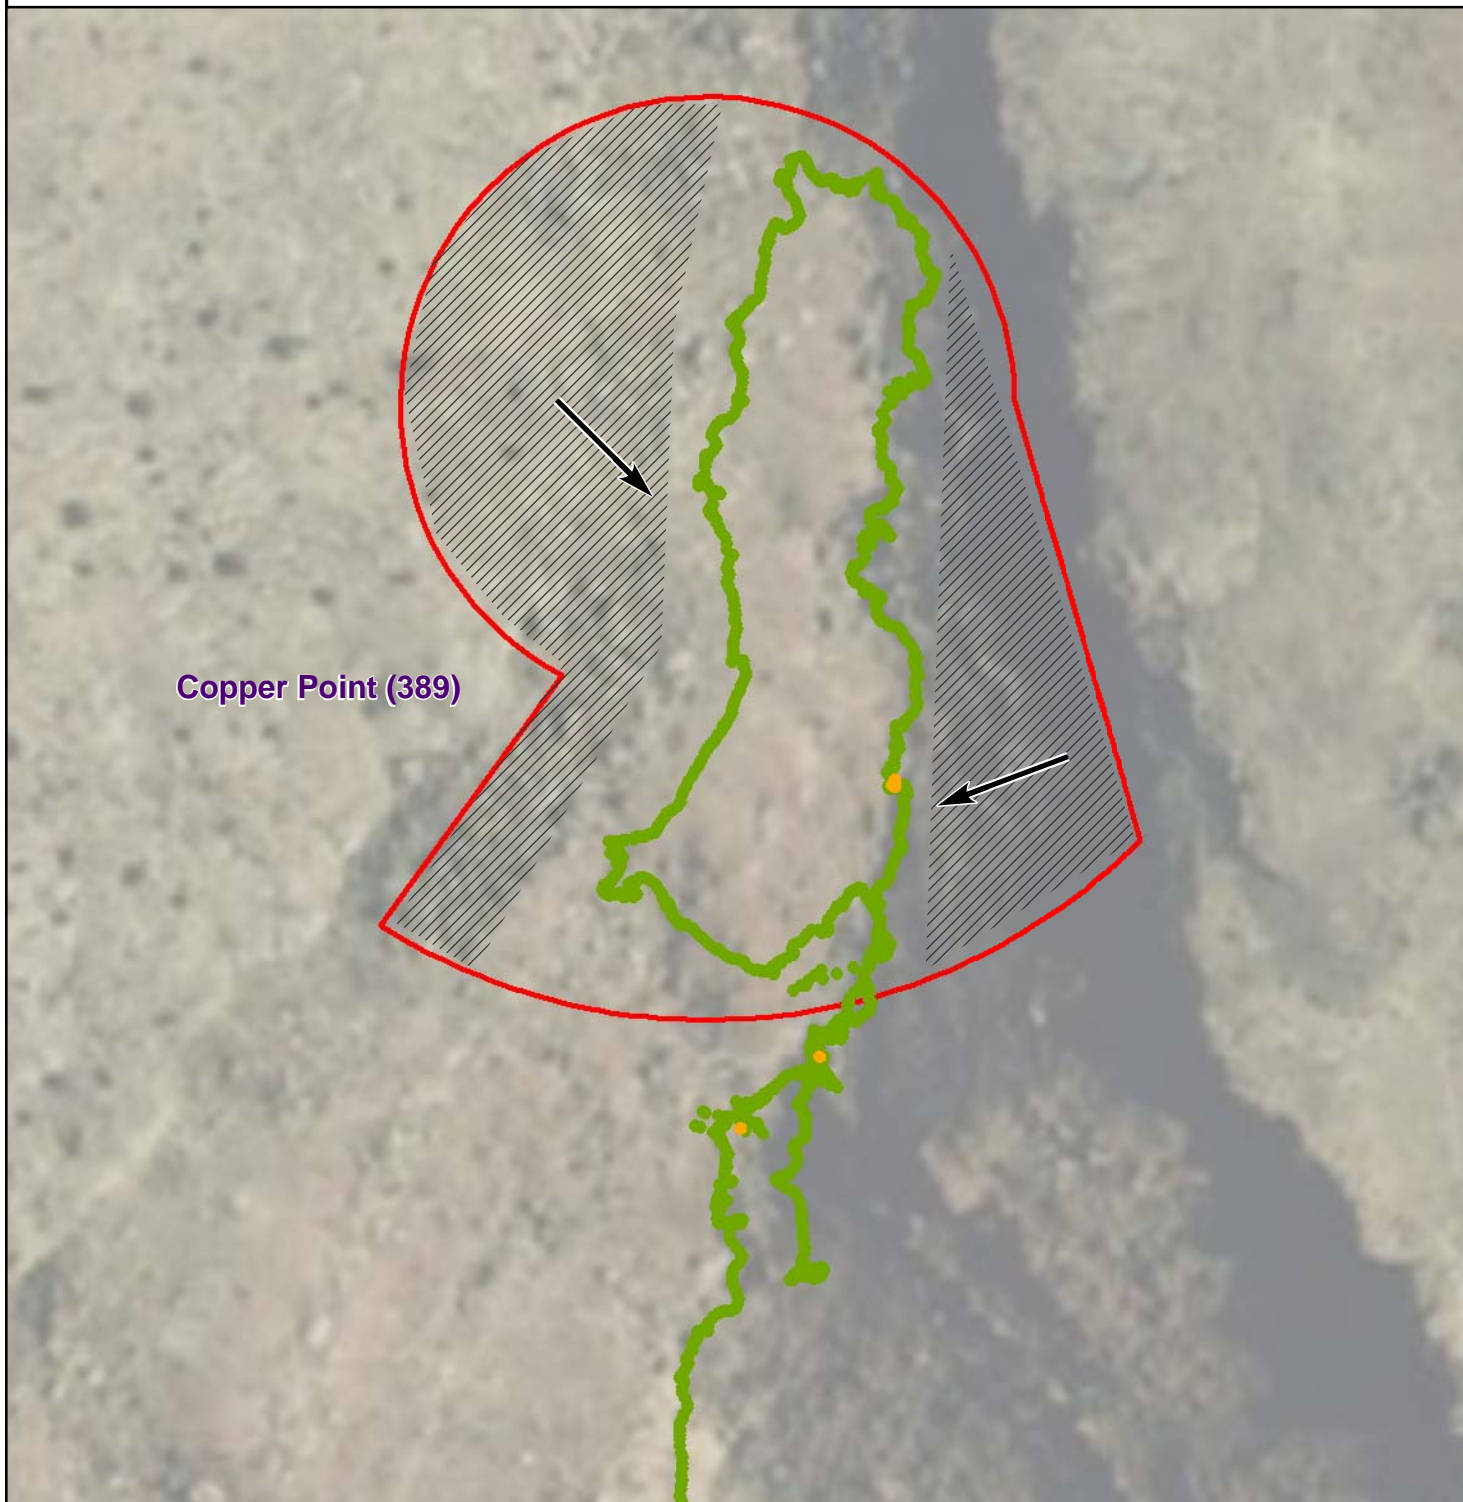
**Figure 1 - Gamma Radiation Measurements, Above Two Times Background  
Copper Point (389)  
Oljato Chapter, Navajo Nation**

**Gamma Radiation Measurements**

- < 2X Background
- > 2X Background

Measured as counts per minute (cpm)

Average background 7,803 cpm

A total of 2,150 gamma radiation measurements were collected from the mine site, ranging from 5,118 cpm to 15,873 cpm. The measurements are represented in Figures 1 and 2.

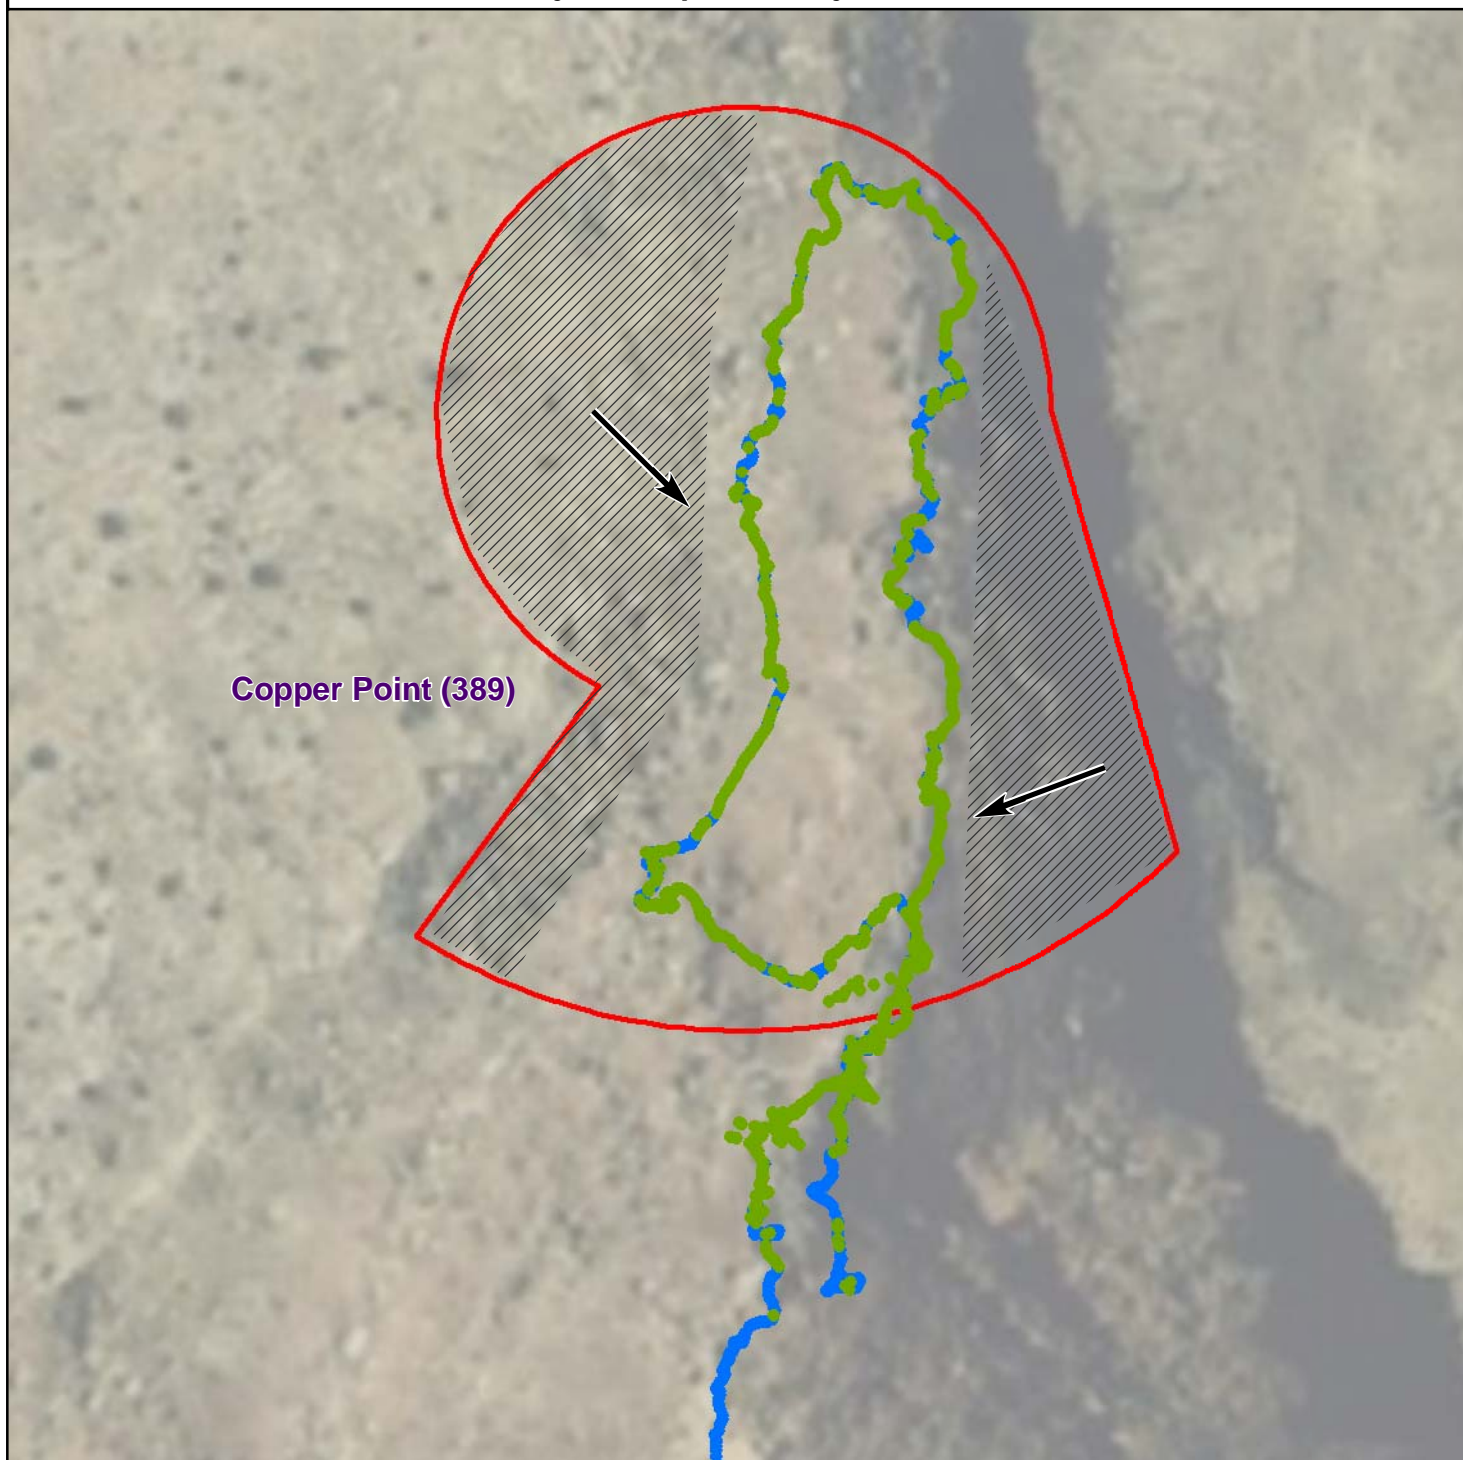
**Figure 2 - Gamma Radiation Measurements  
Copper Point (389)  
Oljato Chapter, Navajo Nation**

**Gamma Radiation Measurements**

- 0 - 10,000 cpm
- 10,000 - 25,000 cpm
- 25,000 - 50,000 cpm
- 50,000 - 100,000 cpm
- 100,000 - 250,000 cpm
- 250,000 - 500,000 cpm
- 500,000 - 1,000,000 cpm

**Average background 7,803 cpm**

**Measured as counts per minute (cpm)**
